シンガポール空港 DAVID CLARK ワイヤレスシステム 使用状況

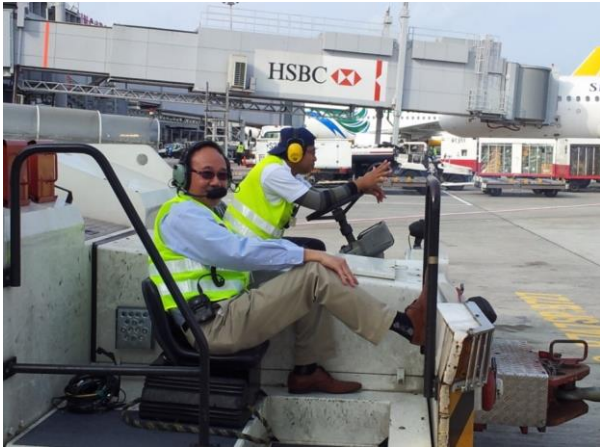
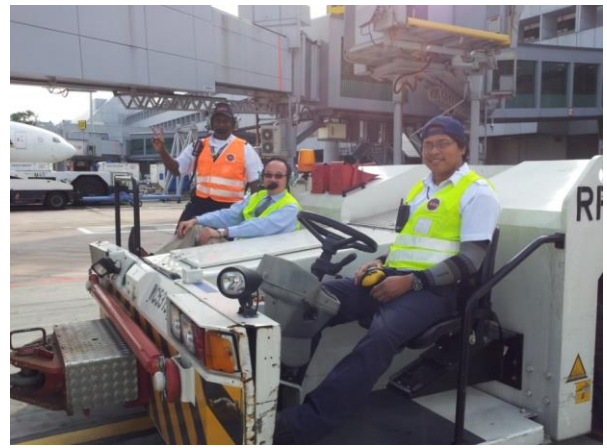
The first 2 pictures were a wireless push back operation done on a Hainan Airline aircraft. Notice that the wireless headset is connected to a belt station and there is no wire between the belt station or headset and the aircraft.

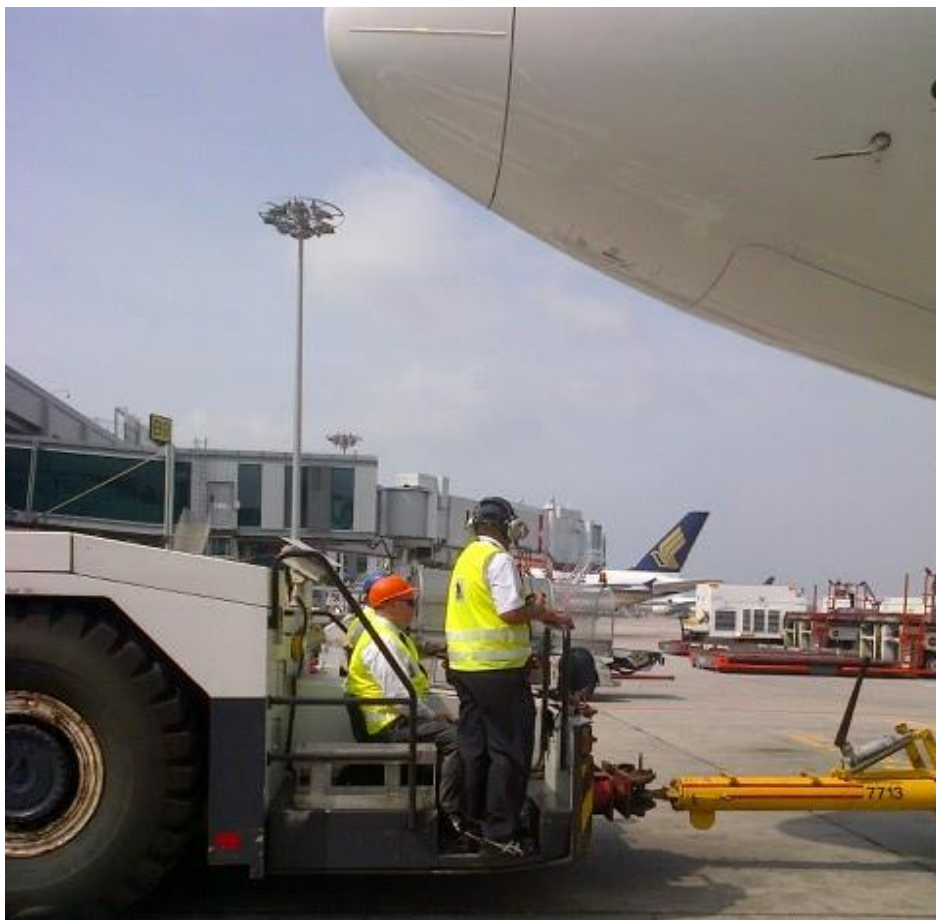
3rd picture just shows a wireless push back done on an Air Asia Aircraft.

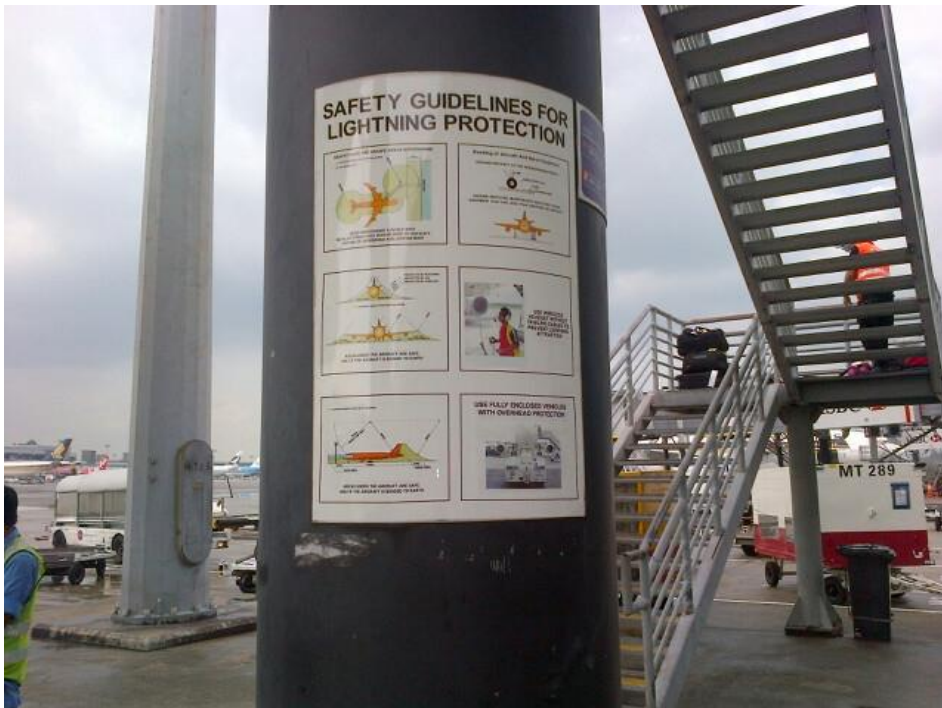
4th picture shows signs posted on all bridge columns displaying precaution needed when thunderstorm is imminent and David Clark wireless headset/system is shown as a requirement.

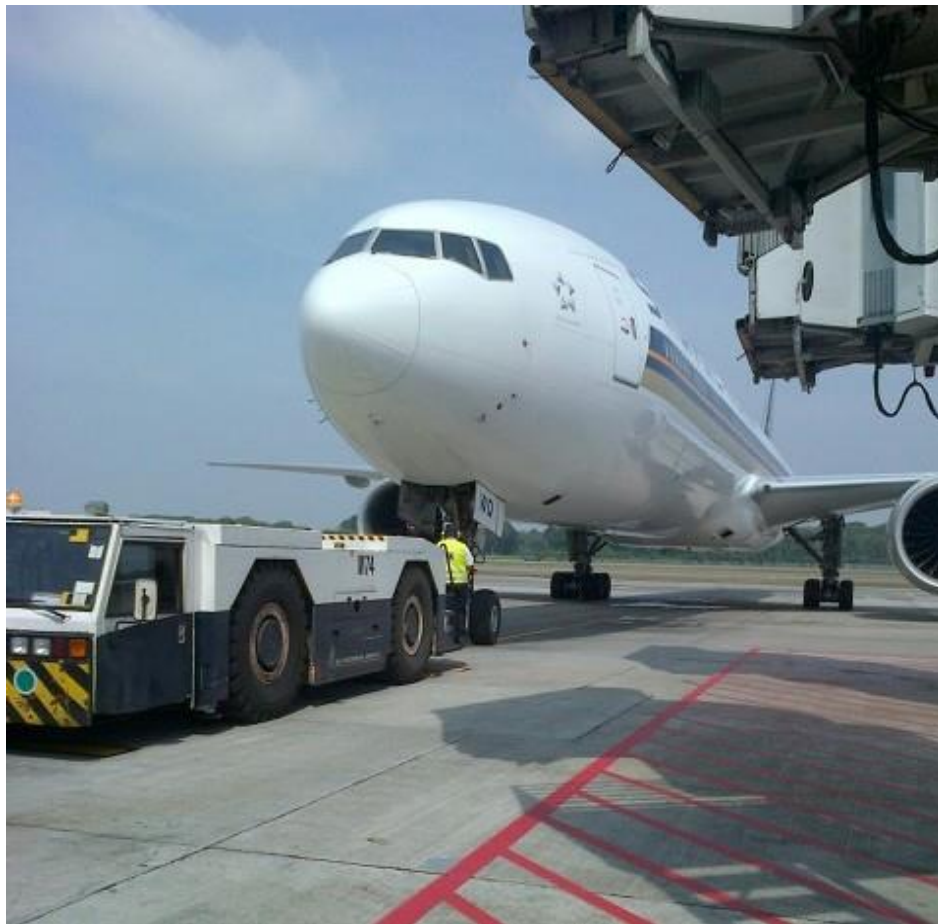
5th picture shows a wireless push back to be executed for an SIA B-777.
